Mam Tor
Edale Valley
Derbyshire
United Kingdom

Landslide Assessment:

Report Id: GR_999999/1

Mam Tor
Edale Valley
Derbyshire
UK

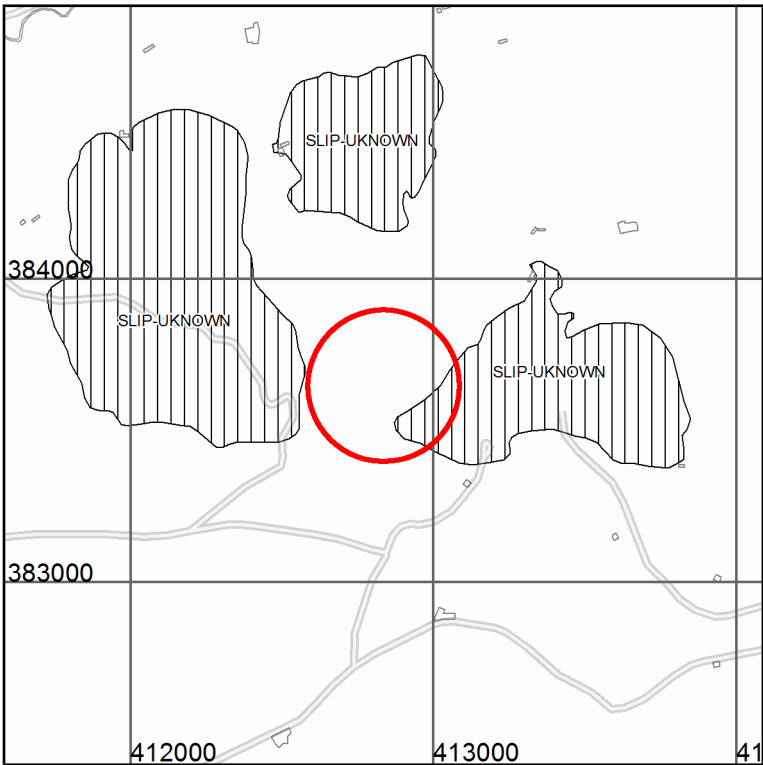
Landslide Deposits

These include natural deposits formed by sliding and other mass-movement of soils and rocks on hill slopes (landslide deposits are a type of ‘Mass Movement Deposits’). An extract of the geology map around your site is provided in this section, taken from the BGS Digital Geological Map of Great Britain at 1:50 000 scale (DiGMapGB-50). The irregular outlines marked ‘SLIP’ indicate the extent of the landslide deposits (that is, not including the landslide back scarp, if any) observed at the time of the geological survey.

Contains OS data © Crown Copyright and database right 2025
Scale: 1:25 000 (1cm = 250 m)
Search area indicated in red

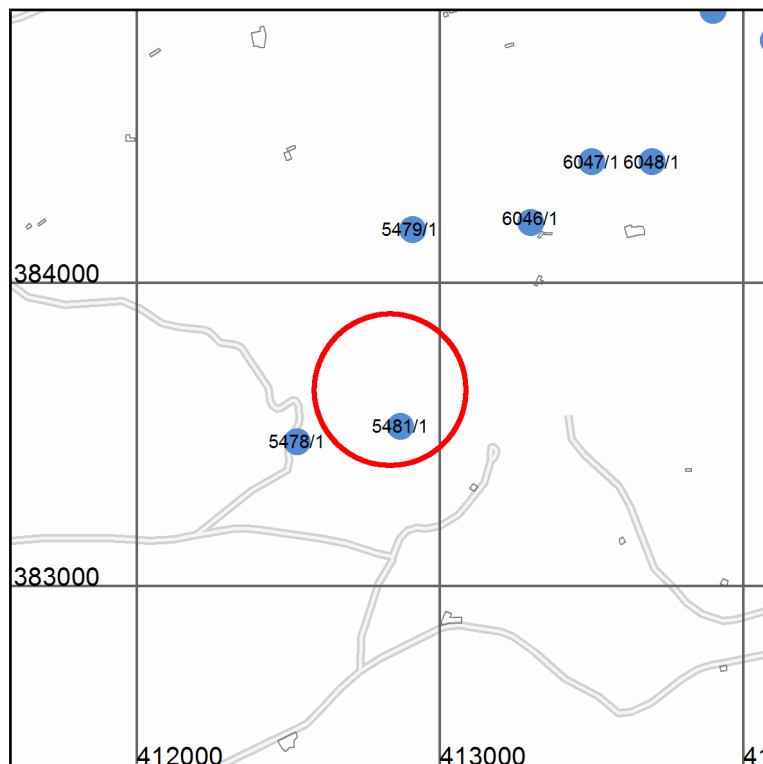
The point symbols show whether the landslide record has been validated by BGS as follows:

The point numbers refer to the NLD ID combined with the Survey No. in the table overleaf

Each landslide within the National Landslide Database is identified by a National Landslide Database ID number and a point location, as shown on this map. The National Landslide Database ID number represents an individual survey of a landslide, rather than just the landslide itself. This is because there could be several phases of movement within or extensions to the same landslide, particularly if it is a large and complex one. **Subsequent surveys of the same landslide may be recorded in the database with the same National Landslide Database ID number but with a new Survey number.** The point symbols at the designated location do not reflect the size and shape of the corresponding landslide, but just denote the recorded presence of a landslide within a range of accuracy. Where possible, each point is located at the highest point on the landslide backscarp feature. This is not always possible to locate as, for example, backscarp information is often omitted from older geological maps. In these cases, the highest point on the mapped landslide polygon is used. If this information is not available, the point is located approximately.

See the map on the previous page for the locations of National Landslide Database ID (NLD ID).

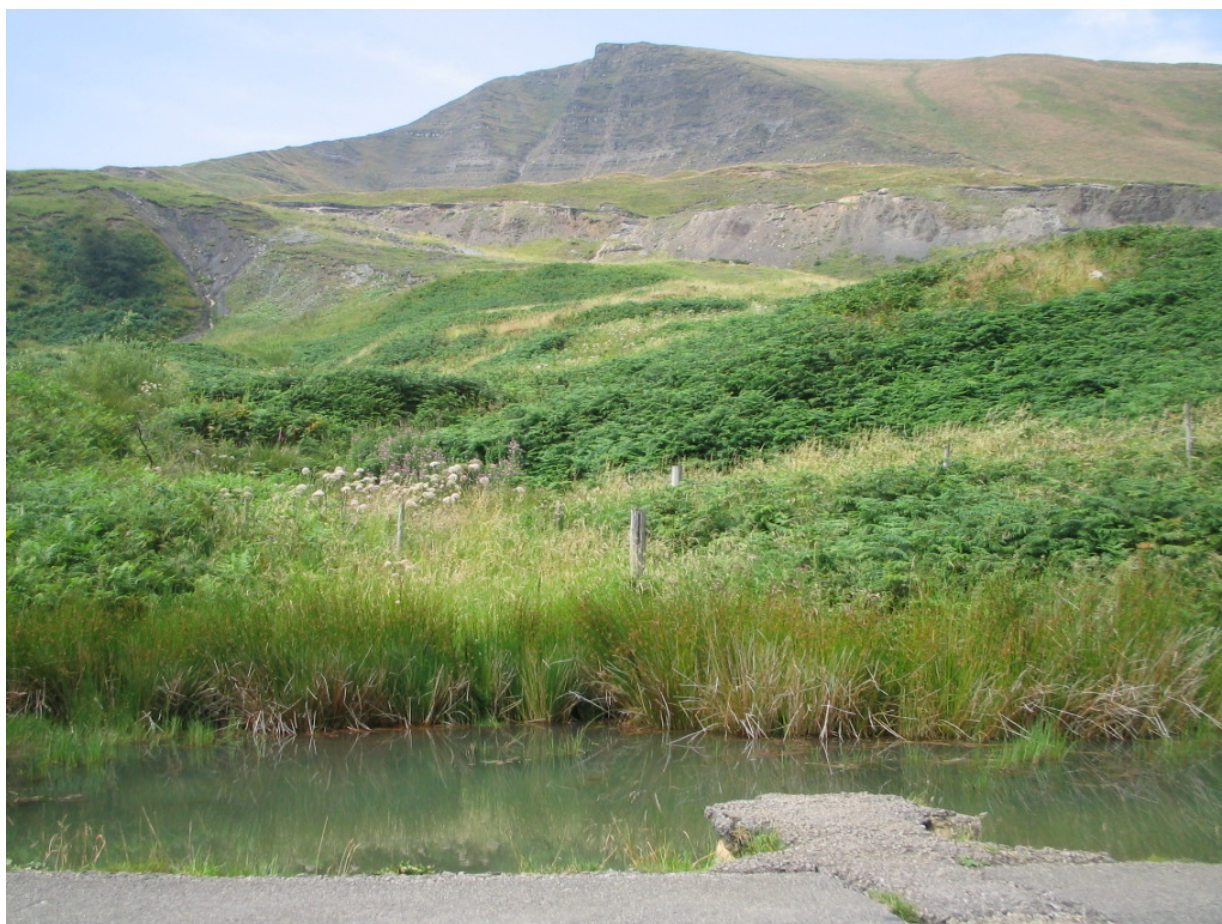
The Mam Tor landslide. Photograph taken from toe looking up towards the backscarp.

Mam Tor (National Landslide Database ID 5481/1). References in table above.

This landslide has been mapped by BGS and is well documented in the literature. The landslide itself is over 4000 years old and is a rotational landslide which has developed into a large flow at its toe (Waltham and Dixon, 2000). It is over 1000 m from backscarp to toe, has a maximum thickness of 30-40 m and the backscarp is over 70 m high.

Waltham and Dixon (2000) have divided the landslide into three distinct zones (backscarp area, transition zone and debris flow) according to their structure as follows:

1. *The upper part of the slide material is a series of rock slices or blocks that were produced by the non-circular rotational failure of the original slope; most of these slices above the upper road show little sign of current movement.*

2. *The central part of the slide is a transition zone, forming most of the ground between the two segments of road; it lies between the upper landslide blocks and the lower debris flow. It is composed of an unstable complex of blocks and slices, some of which can be identified by ground breaks along their margins; they overlie the steepest part of the landslide's basal shear, which was the hillside immediately downslope of the initial failure. The upper road lies along the highest section of the transition zone, which is currently the most active part of the whole slide.*
3. *Disintegration of the lower part of the slipped material has created a debris flow that now forms half the total length of the slide. This is described as a flow because it moves as a plastic deformable mass, but it may also be regarded as a debris flow slide because it has a well-defined basal shear surface.*

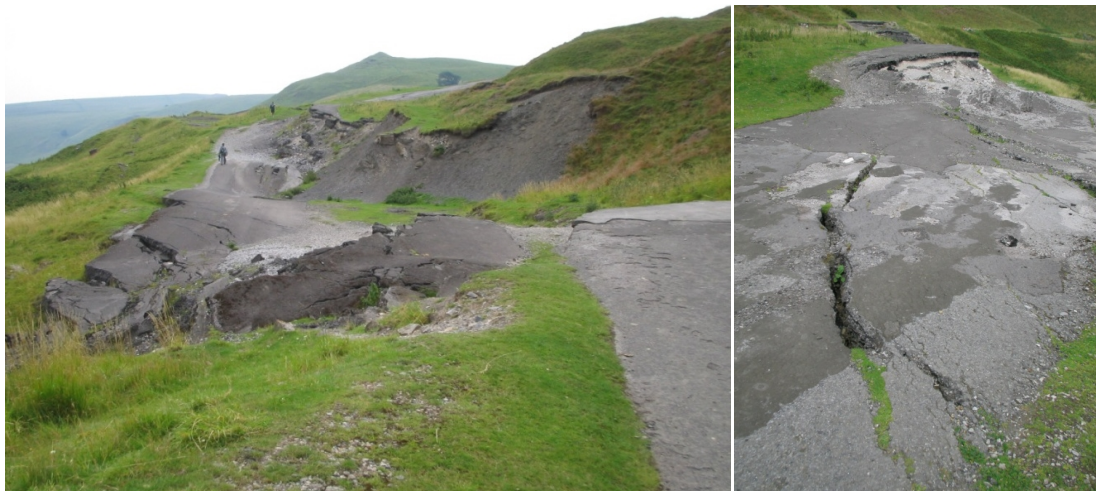
Damage to the road. The road was permanently closed to traffic in 1979.

The Sheffield Turnpike Company first constructed the A625 Manchester to Sheffield road in 1819 using spoil from the nearby Odin mine (National Trust, 2009) and the road crosses the main body of the landslide twice as it winds its way up the slope. The following 160 years saw constant repairs and reconstruction. In 1977, the landslide moved again and the road was restricted to single-lane traffic (Cripps and Hird, 1992). In 1979, the road was permanently closed to traffic and what remains today is an interesting example of landslide movement and repeated road reconstruction and repair.

Mam Tor is unusual in that it is still an active landslide, with spasmodic advances associated with peak rainfall and raised water table conditions. The current recession rate of the backscarp is 7m per century (Cooper and Jarman, 2007).

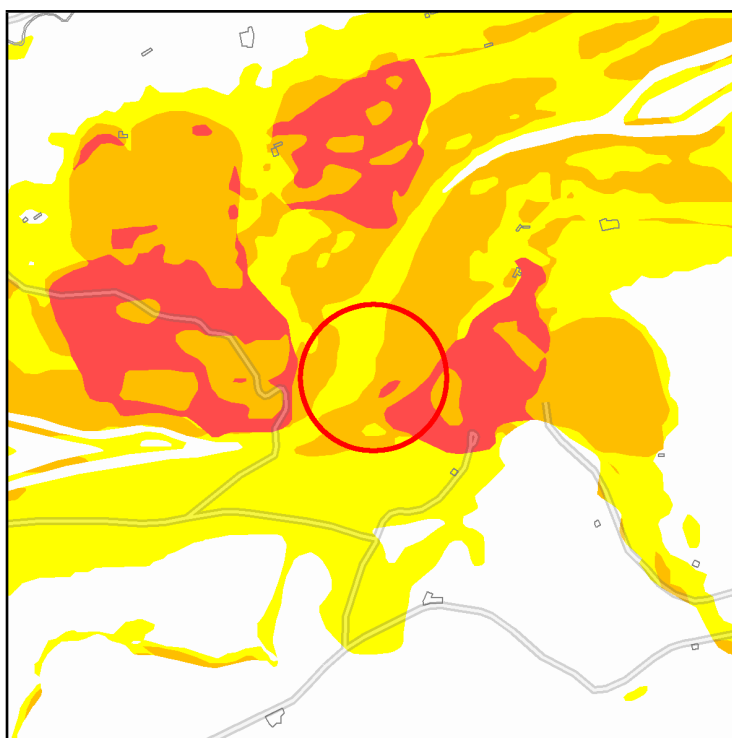
The following map shows where significant natural ground instability due to landsliding could occur. The indicative implications are shown in colour and are described in the key. Please note that a landslide is reported as potentially significant only if it lies at least partly within the search area. The unshaded (white) areas on the map (levels A, B or 'No hazard') represent areas where the conditions that cause natural ground movements due to landslide are considered to be absent or unlikely to be significant. This does not take into account artificial drainage or man made changes to the ground such as buildings or retaining walls.

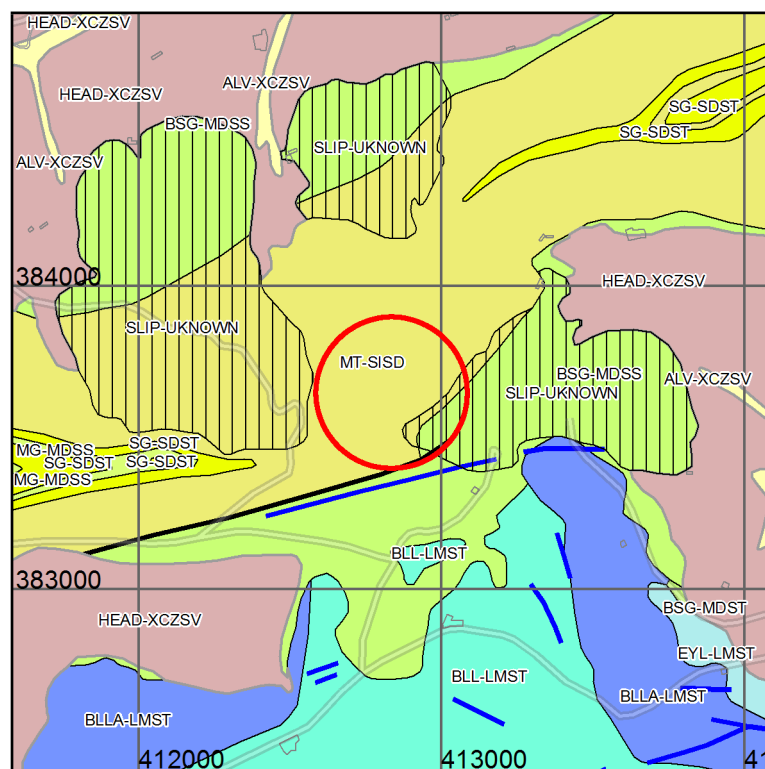
Combined 'Surface Geology' Map

This map shows the surface elements of all four geological layers.

There are several landslides that shape the ridge on the south side of Edale and most of these occur where the weaker Bowland Shale Formation underlies the more competent Mam Tor Beds (described below). This represents the typical slide-flow landslide seen throughout the Pennines where competent permeable rocks overlie weaker strata that are less permeable and prone to deformation.

A minor fault runs through this area, it separates the Edale shales from the Mam Tor beds and cuts through the Mam Tor landslide in the southern edge of the slide scar, below which it is obscured beneath the landslide deposit (Waltham and Dixon, 2000). The fault has a downthrow of about 20 m to the north-west which diminishes to the north-east. The fault also offsets the Odin vein.

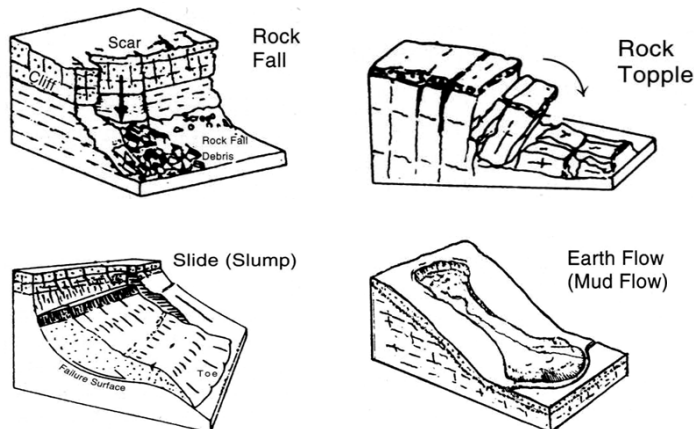
A landslide is the outward and downward movement of rock or soil on a slope. This takes place by falling, toppling, sliding, or flowing.

A landslide is rarely the consequence of a single type of movement; it is usually the result of a combination of several types, changing in nature with conditions and time.
